**FEDERAL AVIATION ADMINISTRATION
AIRWORTHINESS DIRECTIVES
SMALL AIRCRAFT, ROTORCRAFT, GLIDERS,
BALLOONS, & AIRSHIPS**

BIWEEKLY 2003-14

**HARTZELL PROPELLER INC.
AIRWORTHINESS DIRECTIVE
PROPELLER
REVISION**

97-18-02R1 Hartzell Propeller Inc.: Amendment 39-13212. Docket No. 96-ANE-40-AD. Revises AD 97-18-02, Amendment 39-10112

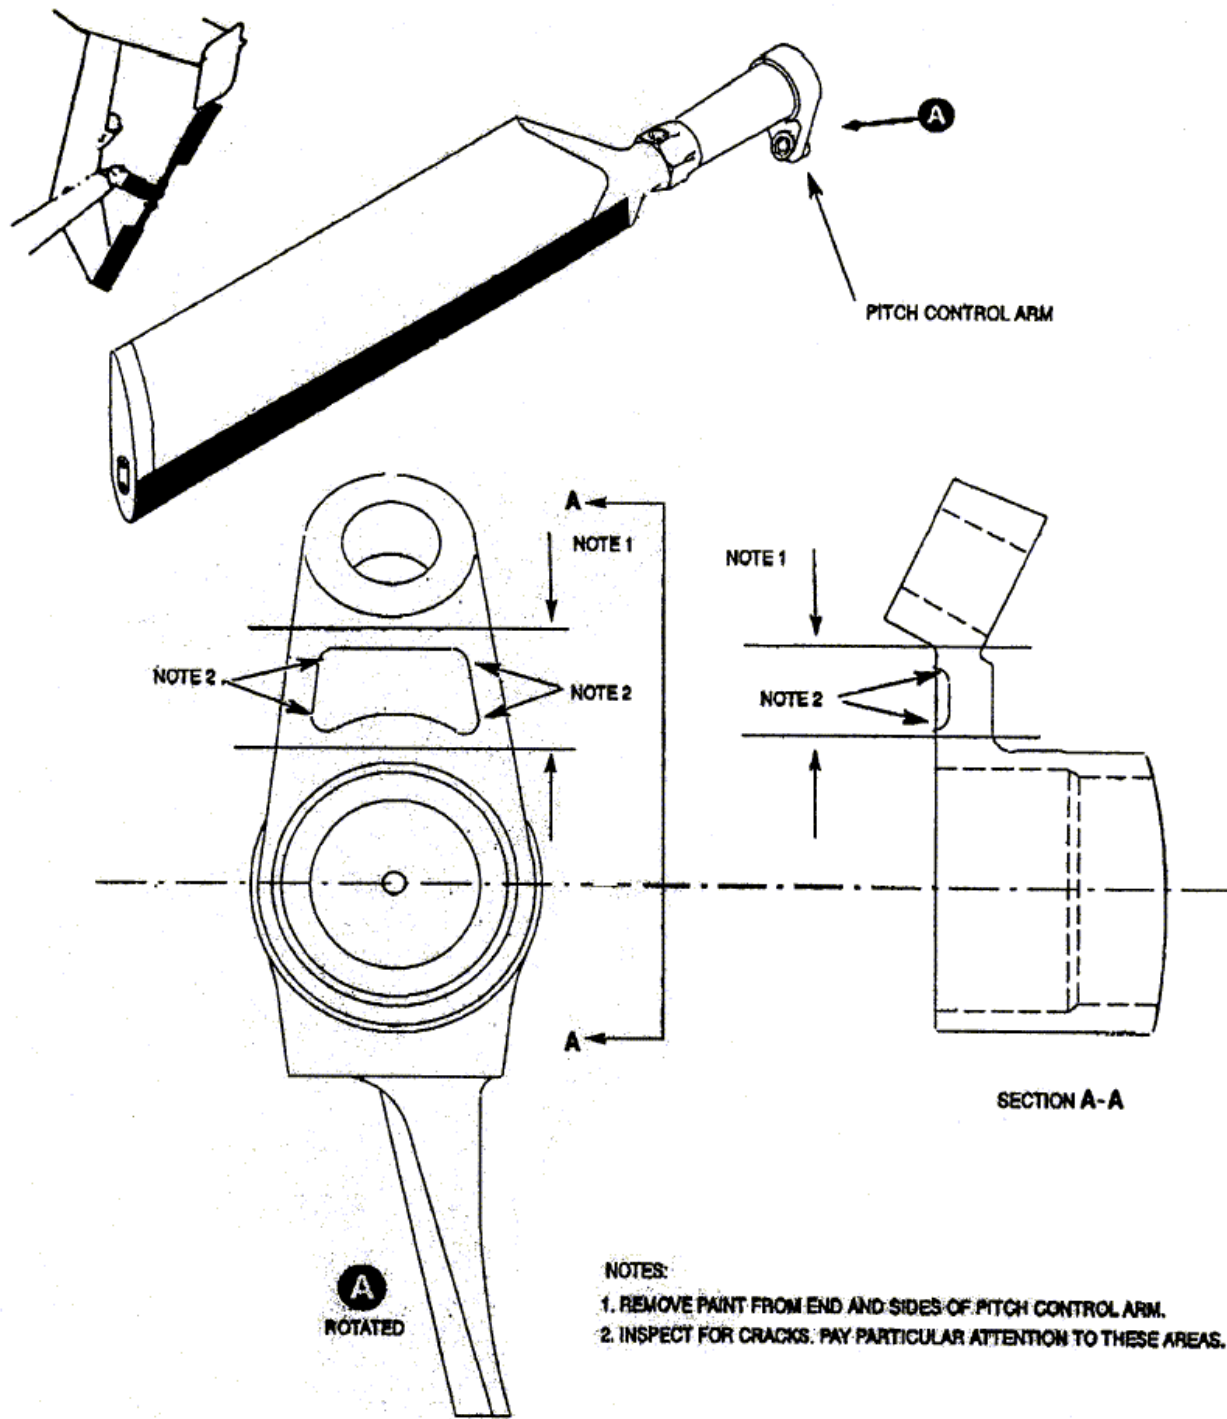
Figure 1. Tail Rotor Blade Assembly Inspection

To prevent a tail rotor blade pitch horn (pitch horn) from separating from the tail rotor blade, leading to an unbalanced condition, vibration, loss of tail rotor pitch control, and loss of directional control of the helicopter, accomplish the following:

(b) Before further flight, perform a one-time visual inspection of each pitch horn for a crack or corrosion in the area indicated by Note 2 in Figure 1 of this AD. Paint removal in accordance with Note 1 of Figure 1 of this AD is not required for the visual inspection.

(a) This airworthiness directive (AD) establishes a new retirement life of 400 hours time-in-service (TIS) for the tail rotor blades listed in the Applicability section. For helicopters with an affected tail rotor blade installed that has 390 through 700 hours TIS, remove and replace the tail rotor blade with an airworthy tail rotor blade within 10 hours TIS.

(d) For helicopters with a tail rotor blade installed that has more than 700 hours TIS, a one-time special flight permit to fly it to a repair facility may be issued only upon completion of an eddy current surface scan of each affected pitch horn (see Figure 1 of this AD). Paint removal in accordance with Note 1 of the Figure 1 of this AD IS required for the surface scan. If a crack is found, remove the tail rotor blade and replace it with an airworthy tail rotor blade before further flight.

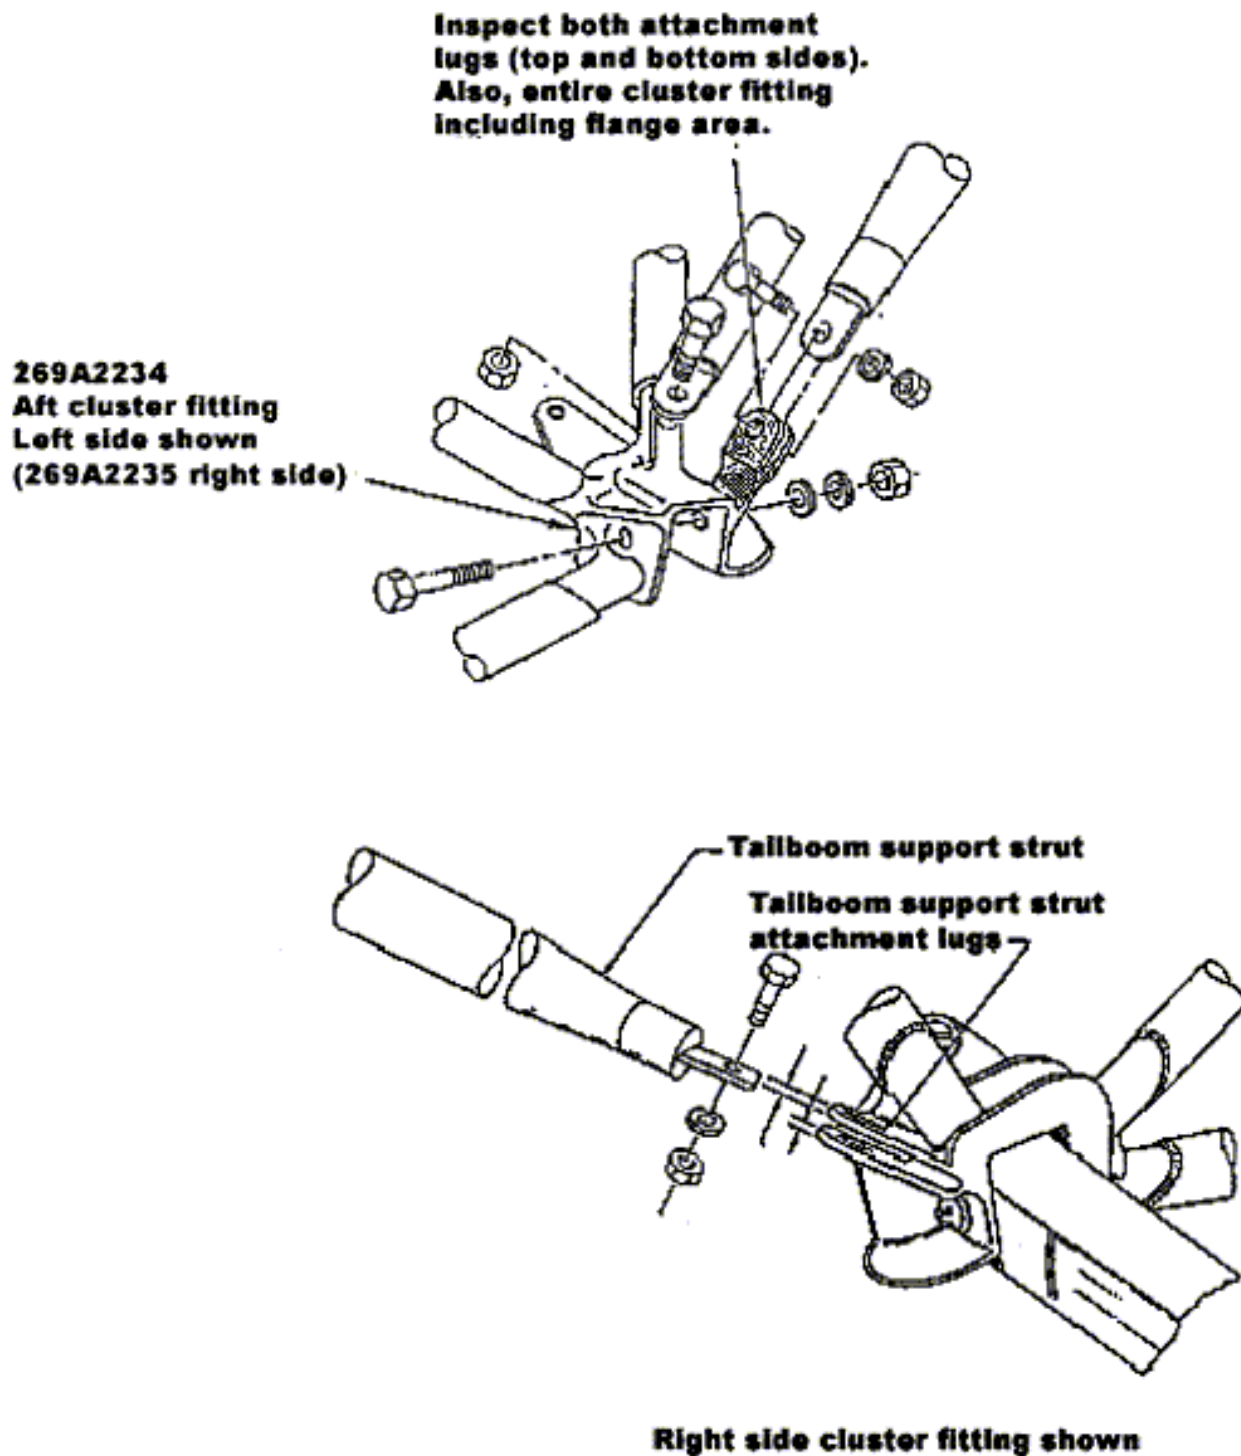
To prevent failure of a tailboom support strut or lug on a cluster fitting, which could cause rotation of a tailboom into the main rotor blades, and subsequent loss of control of the helicopter, accomplish the following:

(2) Dye-penetrant inspect the lugs on each cluster fitting. See the following Figure 1:

(3) If a crack is found, before further flight, replace the cracked cluster fitting with an airworthy cluster fitting.

(c) Within 150 hours TIS or 6 months, whichever occurs first, replace each cluster fitting, P/N 269A2234 and P/N 269A2235, with an airworthy cluster fitting or modify each cluster fitting, P/N 269A2234 and P/N 269A2235, with Kit, P/N SA-269K-106-1. Installing the kit is terminating action for the 50-hour TIS repetitive dye-penetrant inspection for these cluster fittings. Broken or cracked cluster fittings are not eligible for the kit modification.
